United States
Environmental Protection
Agency

TS-PIC-2006
May 1982

Historical Assessment of Cornell-Dubilier -PCB- Related Facility New Bedford, Massachusetts

prepared for
EPA Region 1
and OERR

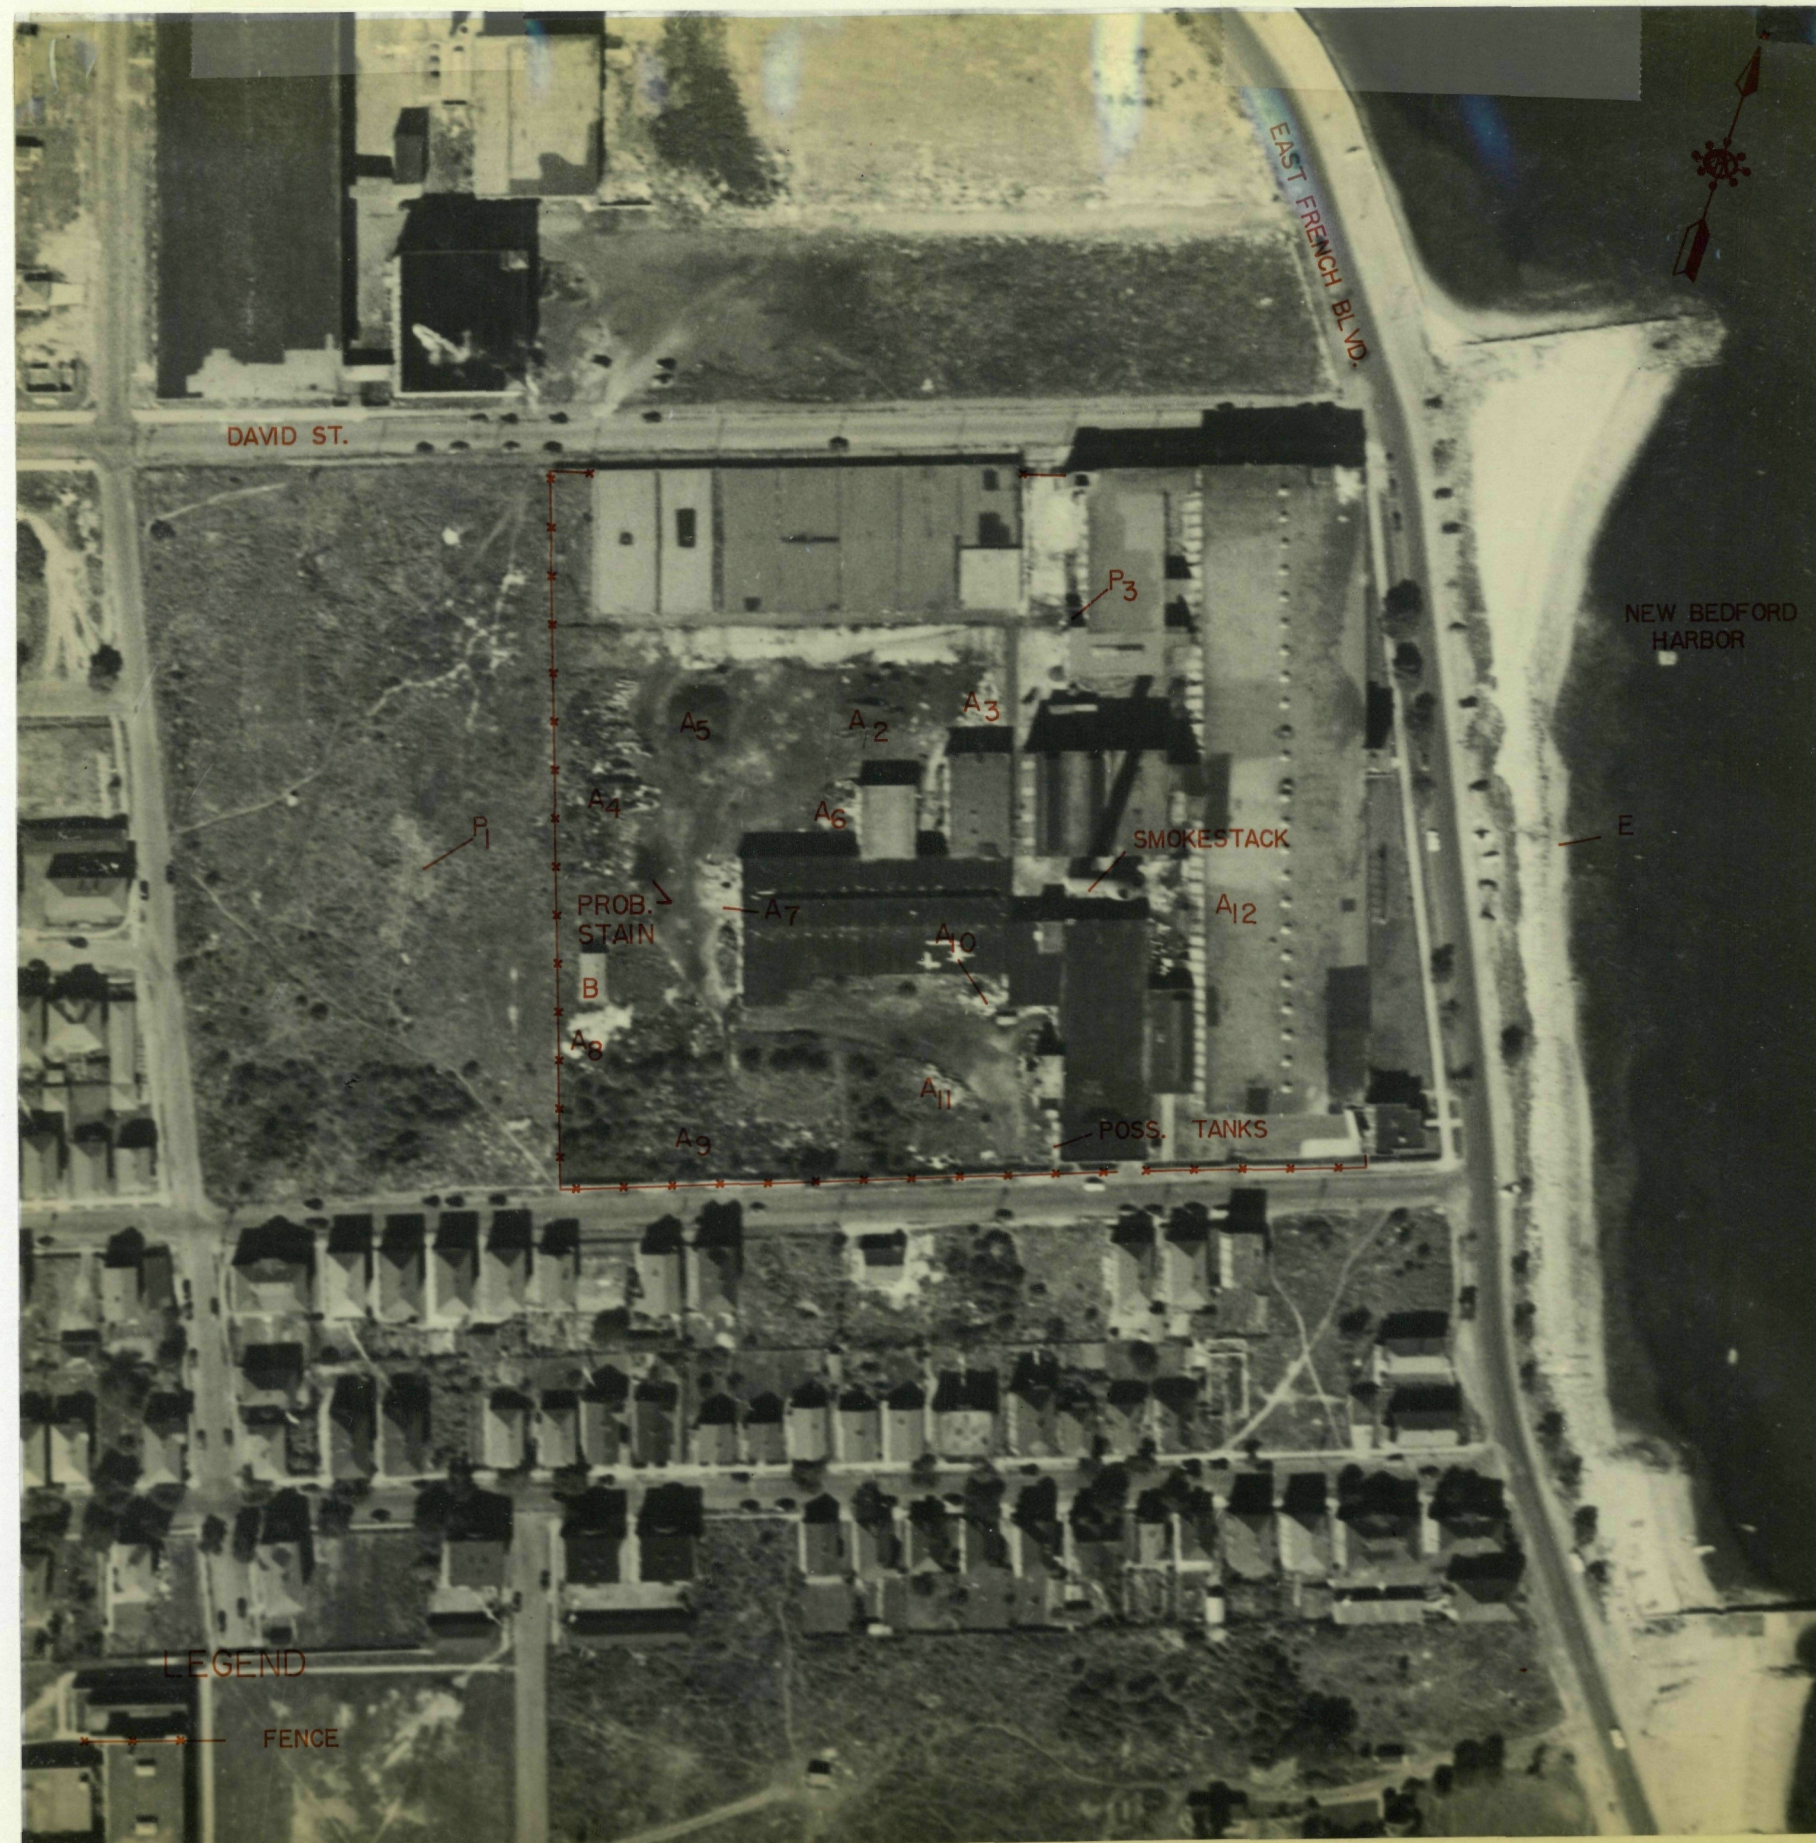
SEPTEMBER 28, 1951

Thirteen years later, in 1951, the configuration of the buildings at the site has been changed only by the addition of one small building on the west side of the site (B on the photo).

However, the lot appears much rougher in texture and more mottled in tone. Many areas of probable drums and/or capacitors, refuse and disturbed ground are now present. A well-defined network of dirt roads and paths crisscrosses the entire lot.

Some possible tanks are visible on the south-central edge of the site.

Photo Areas A₃, A₄, A₆, A₇, A₁₀, A₁₁, and A₁₂ contain refuse which possibly includes drums and/or capacitors.

Area A₈ is a possible waste burial area. This

The rough ground surface and mottled tone of Areas A₄ and A₉ probably indicate waste disposal in these areas. Area A₉ contains over 30 large, deciduous trees in 1951.

Areas A₂ and A₅ contain dark piles of material, probably coal.

P₁ is now dry, but still visible.

P₂ is not visible in 1951 and is located under a probable pile of coal (Photo Area A₅).

P₃ is still visible.

One area of probable ground staining is labeled on the photo.

A drainage channel cuts into the hurricane barrier at Photo Area E. It appears to be the discharge point of a subsurface pipeline.

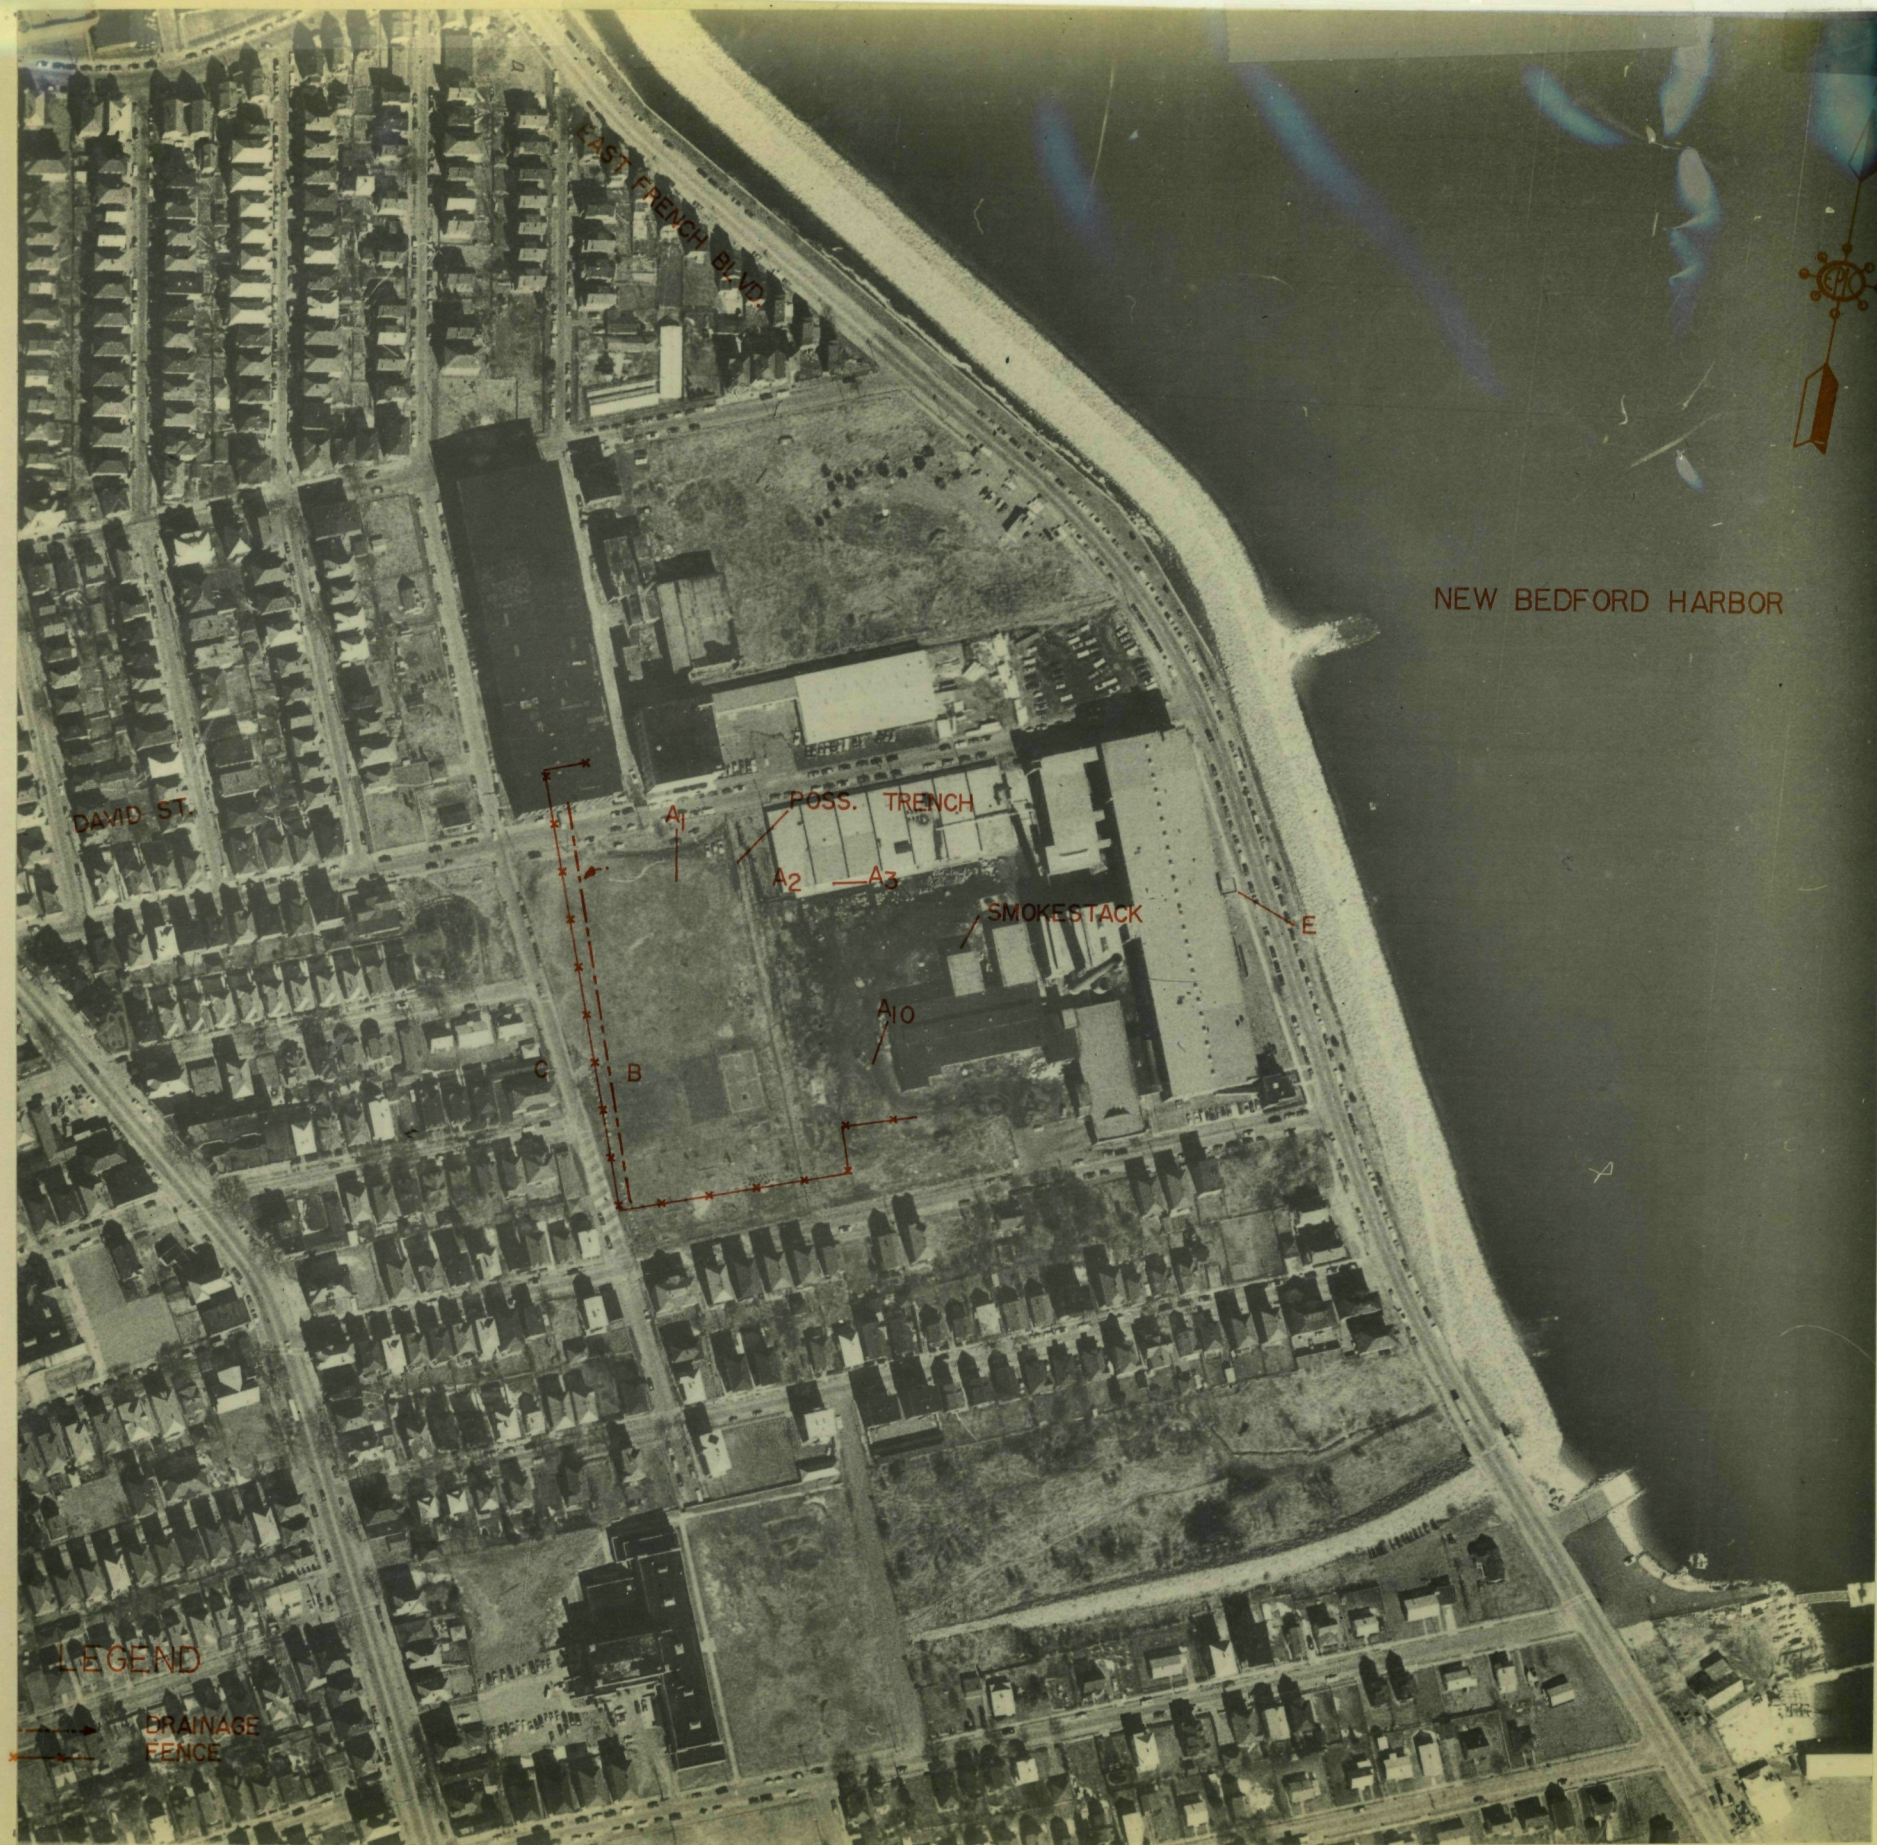
ANALYSIS OF PHOTOGRAPH TAKEN FEBRUARY 27, 1974

Area A₁ now appears to contain a large number of possible drums and/or capacitors, as well as other possible refuse. These replace the probable light-toned gravel driveway that was visible from 1938 to 1966. There is a possible trench in this area.

Area A₃ no longer shows a pile of refuse, but a possible structure is visible.

Area A₁₀ shows an increased amount of mounded material and probable refuse.

The probable pile of coal present at Area A₂ from 1938 to 1966 is no longer present.

A channel now runs along the west side of the site. The direction of possible flow cannot be determined.

None of the pools of liquid visible on earlier photos are now visible.

A basketball court (Area C) has been built outside the fence in the approximate former location of P₁. (P₁ is visible on the 1938, 1951 and 1962 photos.)

A small discolored area appears in the water at Area E. There is some evidence of active discharge at Area E in all the photos from 1951 to 1974. In the 1938 coverage, this area is obscured by the fiducial mark of the camera.

The small building (Area B) that appeared on the 1951 photo is no longer present. A light-toned area remains where the building stood.
